Existing Conditions Assessment

D.M. Wills Project Number 13-2907

D.M. Wills Associates Limited
Partners in Engineering
Peterborough

June 2018

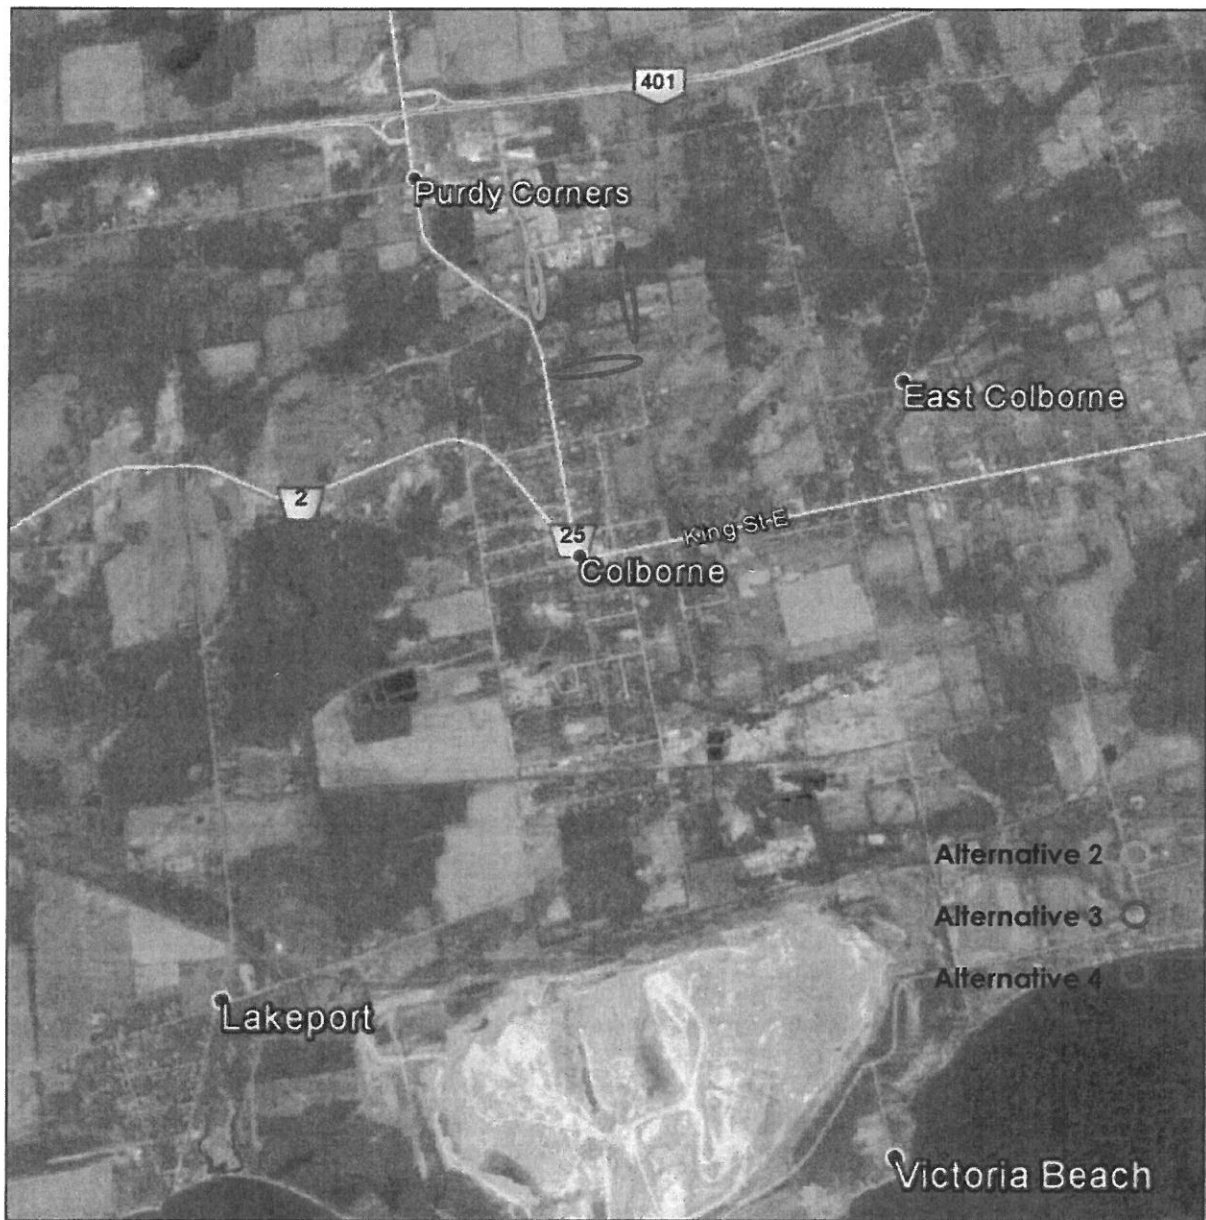
Figure 1 - Location of Alternatives 2, 3 and 4 Crossing Undeveloped Land

Existing environmental conditions were assessed for the three remaining alternatives. Alternatives 2 and 3 are located within the drainage area of two tributaries to Colborne Creek, a cold-water creek that flows to the west of Colborne and eventually flowing into Lake Ontario, east of Lakeport. Alternative 4 is to the south, located between Elgin Street North and Percy Street (**Figure 1**).

Both the North and South headwater tributaries appear to be associated with an unevaluated wetland that drains an area east of Elgin Street North. They join approximately 350 m downstream of Percy Street. This combined tributary flows into the main Colborne Creek just west of the Town of Colborne, approximately 1.4 km further downstream. Since the fish species list is for the entire watercourse, it can be assumed that the majority of species would be found in the lower reaches (downstream of Percy Street) where the Colborne Creek is larger, well defined and provides suitable habitat.

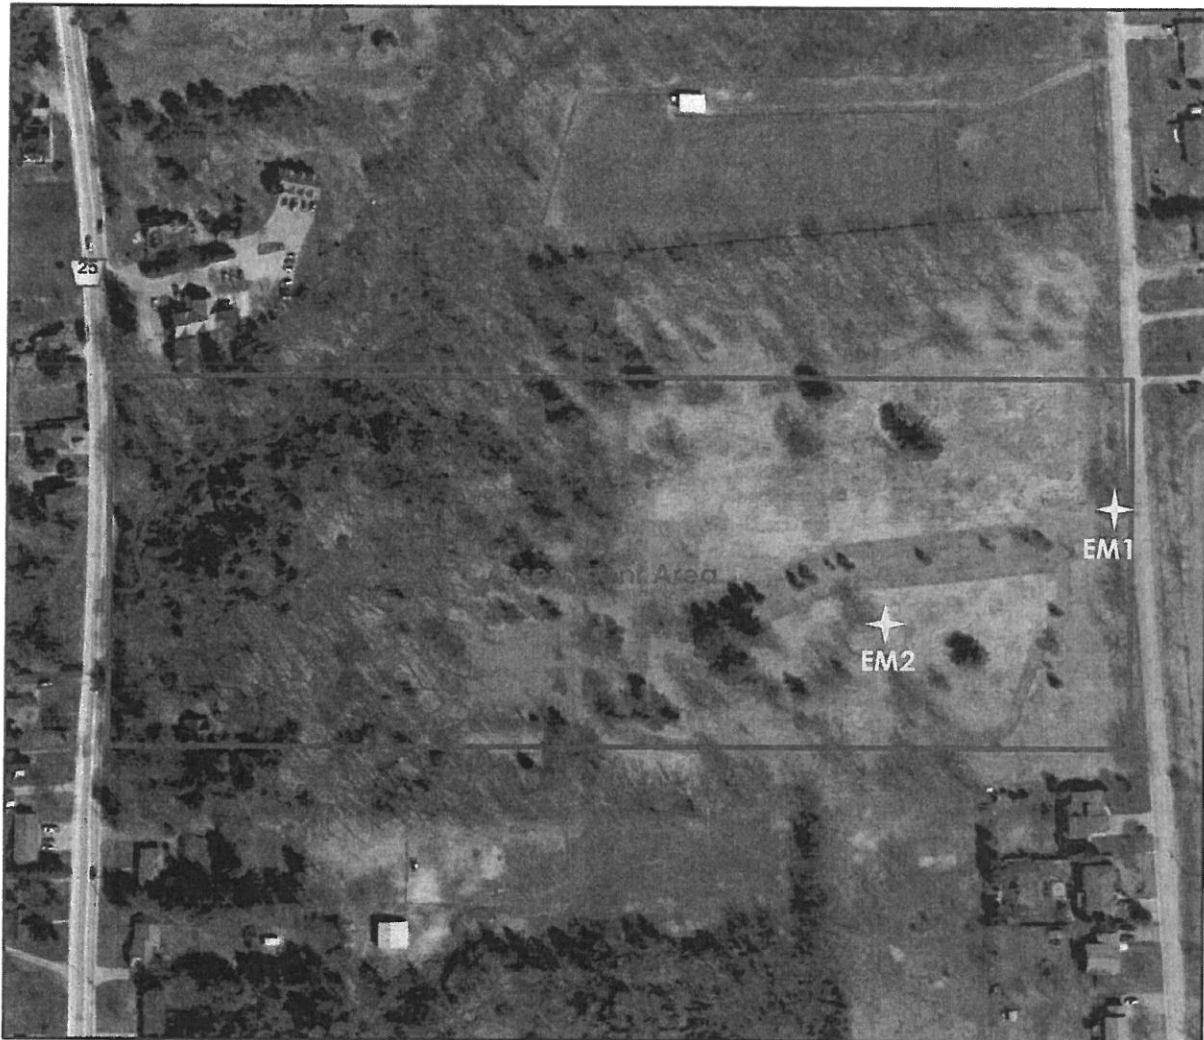
Figure 4 - Assessment Area for Alternative 4 Alignment

The Assessment Area can be divided into two separate vegetation communities. The western portion of the Assessment Area is a densely vegetated forest with various plant and tree species found throughout (**Photos 19-22**). Field investigations identified the following species in the canopy and sub-canopy of the forested area: Sugar Maple, White Pine, Eastern Hemlock, American Beech, White Spruce, Alternate-Leaf Dogwood, Staghorn Sumac, Manitoba Maple, Eastern White Cedar, Red Spruce, Red Oak and Speckled Alder. Plant species found throughout the understory were False Solomons Seal, Coltsfoot, Field Horsetail, Bracken Fern, Sheep Laurel, Kidney-leaf Buttercup, Canada Mayflower, White Trillium and Common Periwinkle.

The eastern portion of the Assessment Area is mainly dominated by various grass species with small stands of trees scattered throughout (**Photos 16-18** and **23**). Plant / tree species found were Dandelion, Riverbank Grape, Virginia Creeper, Goldenrod, Manitoba Maple, Black Walnut, Red Cedar, Dog Strangling Vine, Reed Canary Grass, Buckthorn, Crown Vetch, Eastern White Cedar, Wild Raspberry, Buckthorn, Staghorn Sumac, White Pine, Common Milkweed, Common Mullein, White Spruce, Field Horsetail, Bull Thistle, Sugar Maple, Sensitive Fern, Speckled Alder, Queen Anne's Lace and Large-tooth Aspen.

Alternative 4 proposes to replace the existing sanitary sewer network in the Industrial Park with an expanded capacity sanitary network in terms of pipe size (sanitary capacity) and area serviced. This alignment will make use of a proposed easement between Elgin Street and Percy Street which is located on private property owned by Linda Hinton. The proposed sanitary main will connect with the existing Colborne sanitary system on the west side on the proposed easement on Percy Street (**Figure 4**).

The northwestern portion of the Assessment Area contains a small stream running through in the southwestern direction (**Figure 4** and **Photos 21-22**). Although no fisheries sampling was completed, it did not appear as though the stream was of sufficient habitat to contain fish. The upper portions of the stream had minimal water flow. The length of the stream was briefly observed and no fish were seen during the field visit. After speaking with the property owner, Linda Hinton, she indicated that the stream did in fact dry up during the summer / fall months.

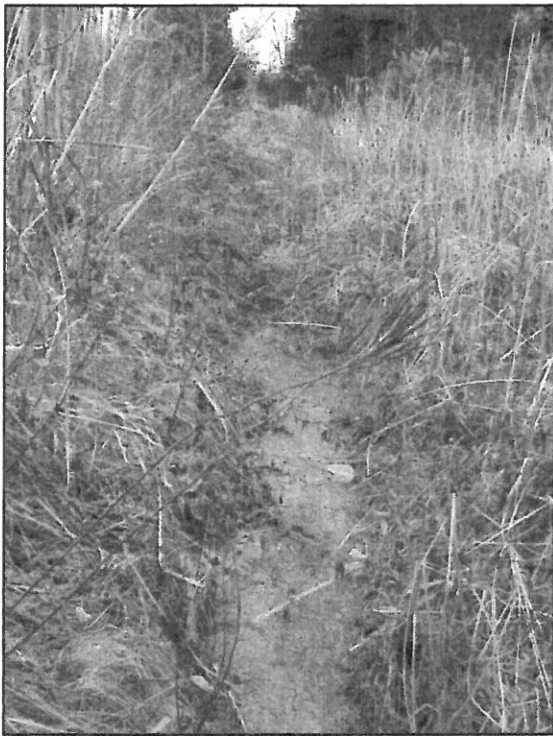
Photo 4

Upstream view of North Headwater Tributary just downstream of the edge of cedar woodlot.

At the downstream end of the woodlot, the channel widened to a width of 0.80 m (0.11 m deep with a sandy bottom) (**Photo 4**). A second channel, draining farm land behind the commercial property to the west, flowed into the Study Area channel. Downstream of this confluence, a small drop of approximately 0.55 m was noted in the channel and this was associated with a small bridge over the channel. From the edge of the woodlot to confluence with the roadside ditch, a distance of approximately 70 m, the channel form is straight with widths ranging from 1.8 to 2.2 m (**Photo 5**). Depths ranged from 0.06 to 0.14 m. Substrates consisted predominantly of silt and sand with pockets of gravel. Watercress (*Nasturtium officinale*) and scattered smartweed (*Polygonum* sp.) were noted throughout this reach of the watercourse. The presence of watercress suggests groundwater inputs occur in this section of the watercourse. On the west side of the channel, fill material had been placed immediately adjacent to the channel.

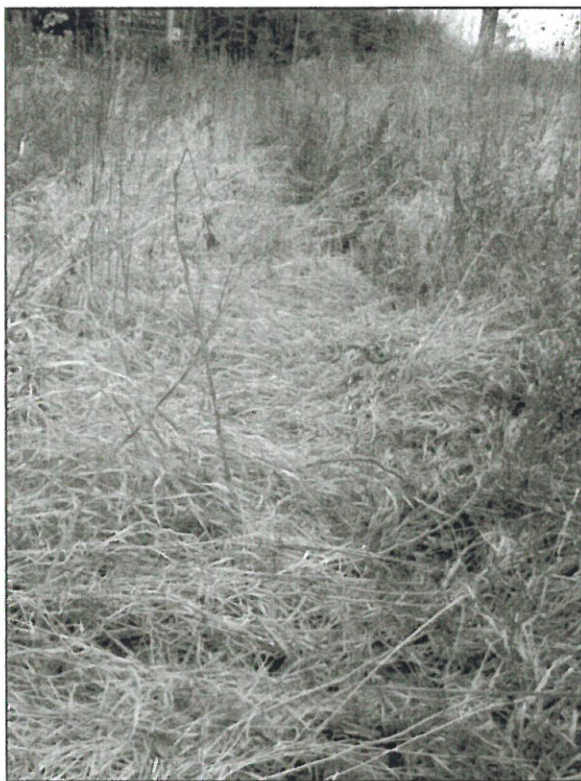
Photo 6

Downstream view of North Headwater Tributary flowing parallel to Percy Street beside Hoselton Sculptures.

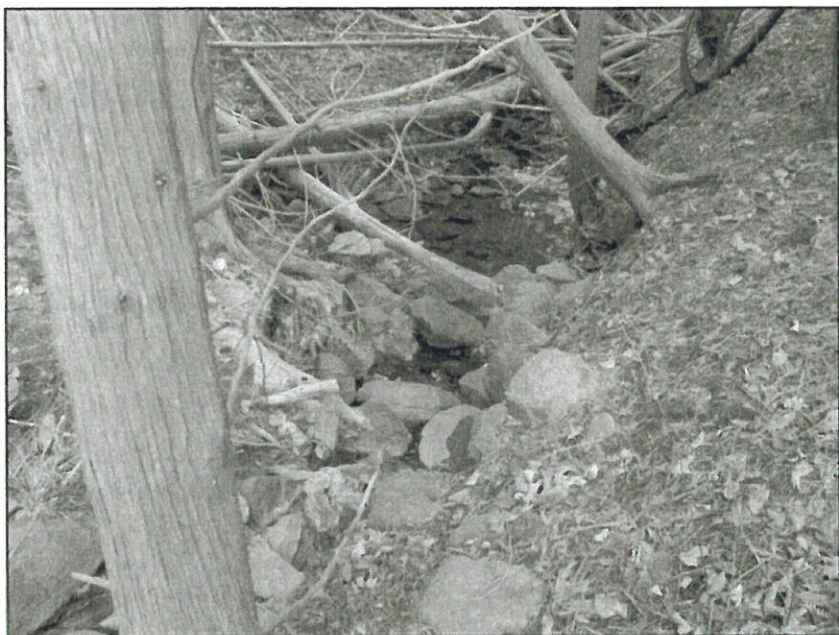
Photo 7

North Headwater Tributary downstream of entrance culvert to Hoselton Sculptures.

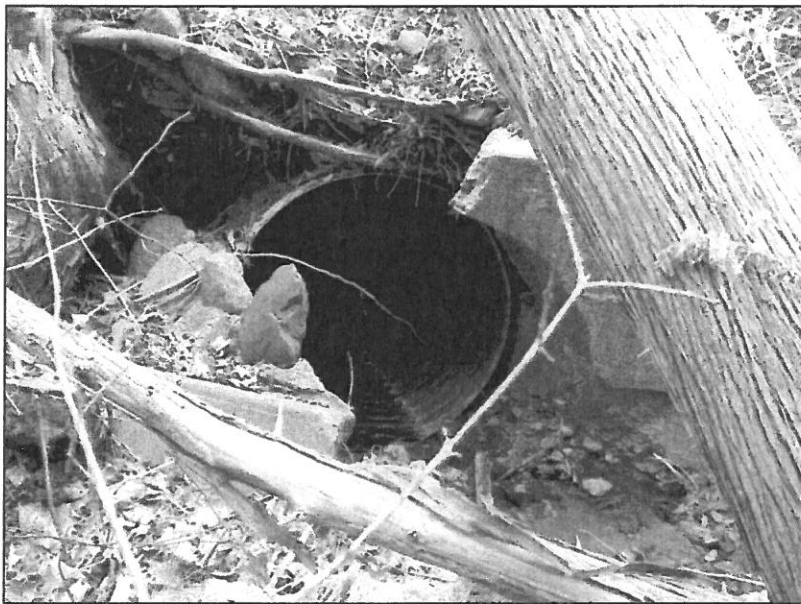
Photo 8

Inlet of culvert under
Percy Street (southwest
view).

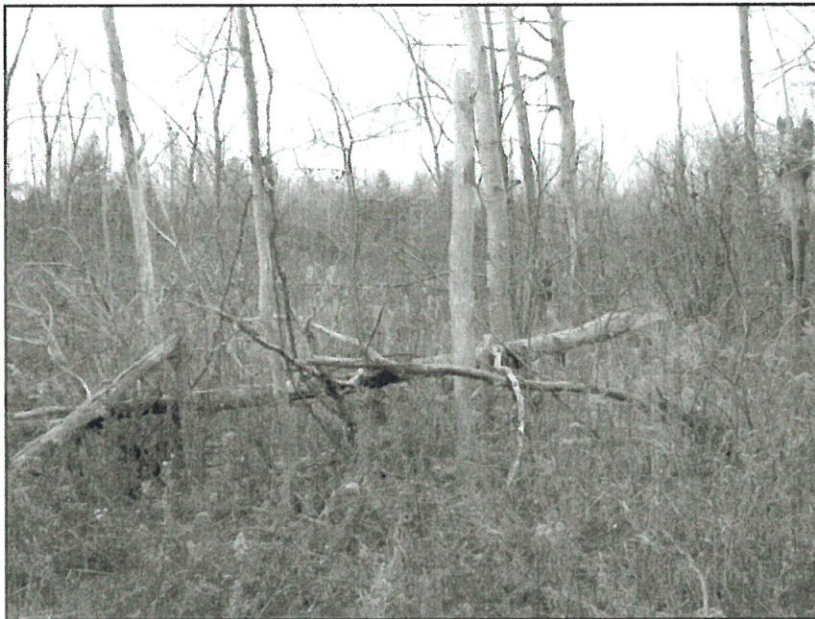
Photo 9

Wetland area to the west of Elgin Street North (west view).

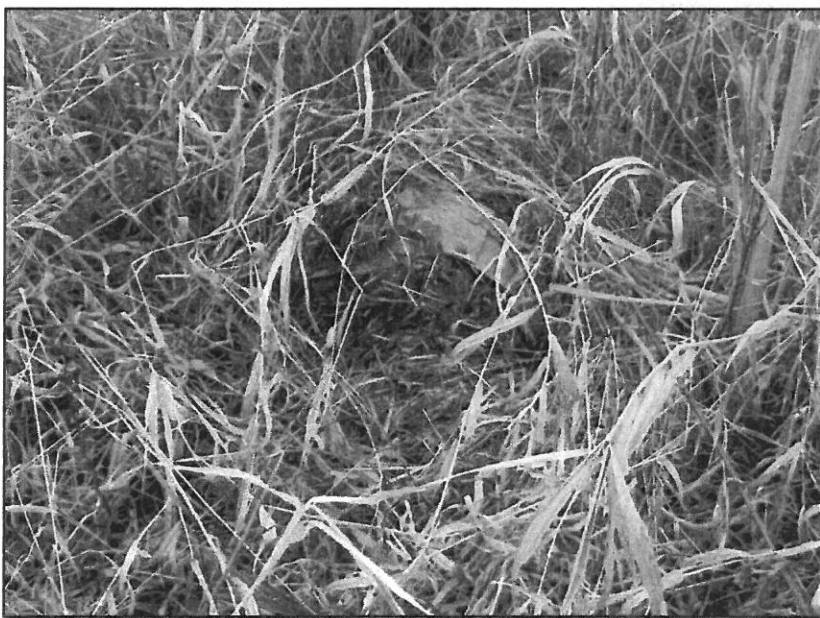
Photo 12
East end of blocked
culvert under Elgin
Street North.

In the wetland area, there were some small open water areas beyond the ROW but it was well vegetated for the most part. In the middle of the wetland, a 400 mm CSP was noted under Elgin Street North but the east end of the culvert was plugged (**Photo 12**). As a result, very little water was passing under the road. The west end of the culvert was not visible (**Photo 13**).

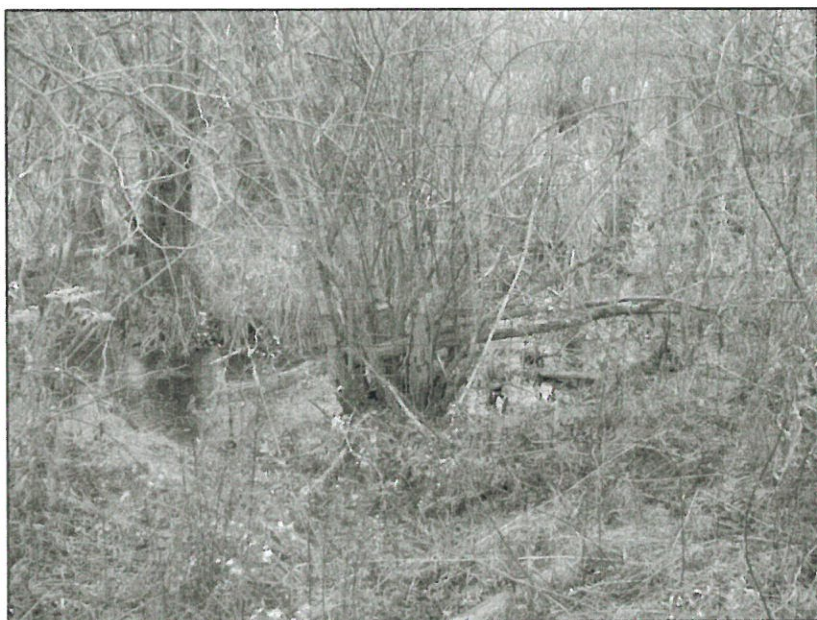
Photo 13
West side of Elgin Street
North in the vicinity of
the cross culvert noted
in Photo 12.

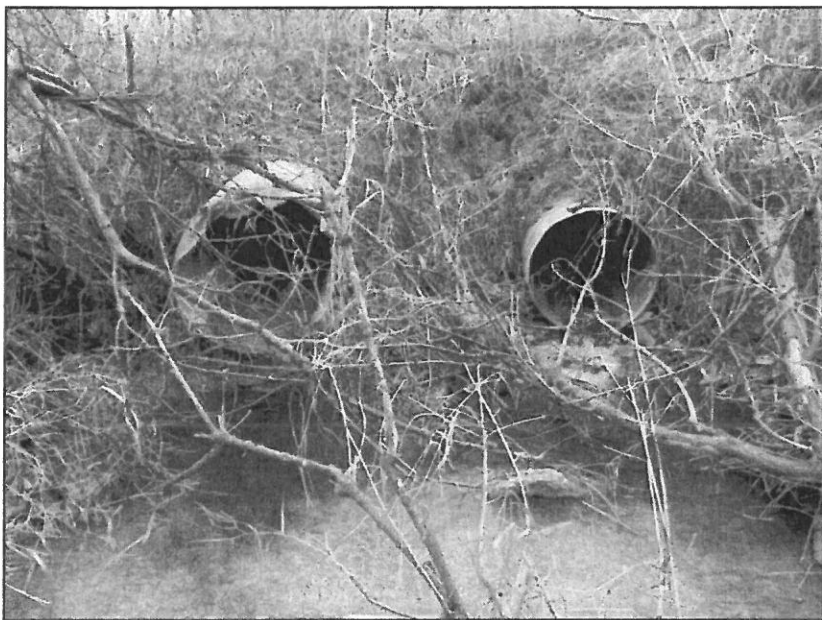
Photo 15

Upstream view of
culvert outlets on west
side of Elgin Street
North.

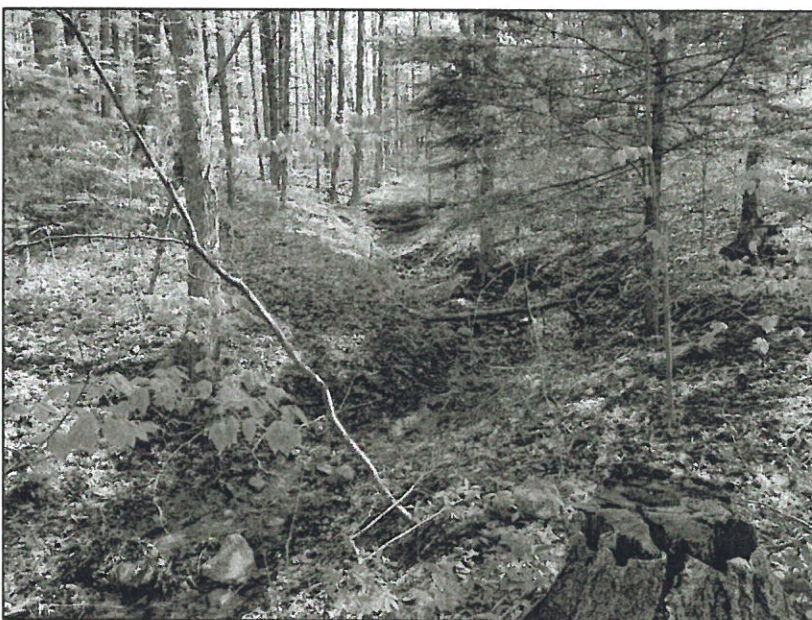
Photo 21

Water flowing between a gully at the northwestern portion of the Study Area. Photo is looking east.

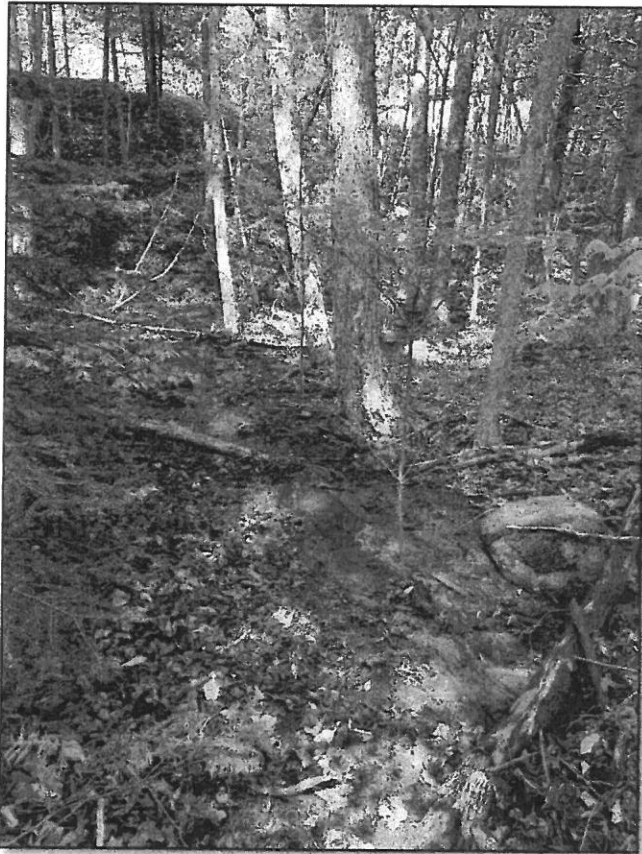
Photo 22

Water flowing between a gully at the northwestern portion of the Study Area. Photo is looking west.
